**ANALYTICAL RESULTS REPORT  
for PHASE II ENVIRONMENTAL SITE ASSESSMENT**

**WHEAT RIDGE 7100/7150 WEST 38<sup>TH</sup> AVENUE  
TARGETED BROWNFIELDS ASSESSMENT (TBA)  
Wheat Ridge, Jefferson County, Colorado**

**TDD No. 0909-08**

**JANUARY 25, 2010**

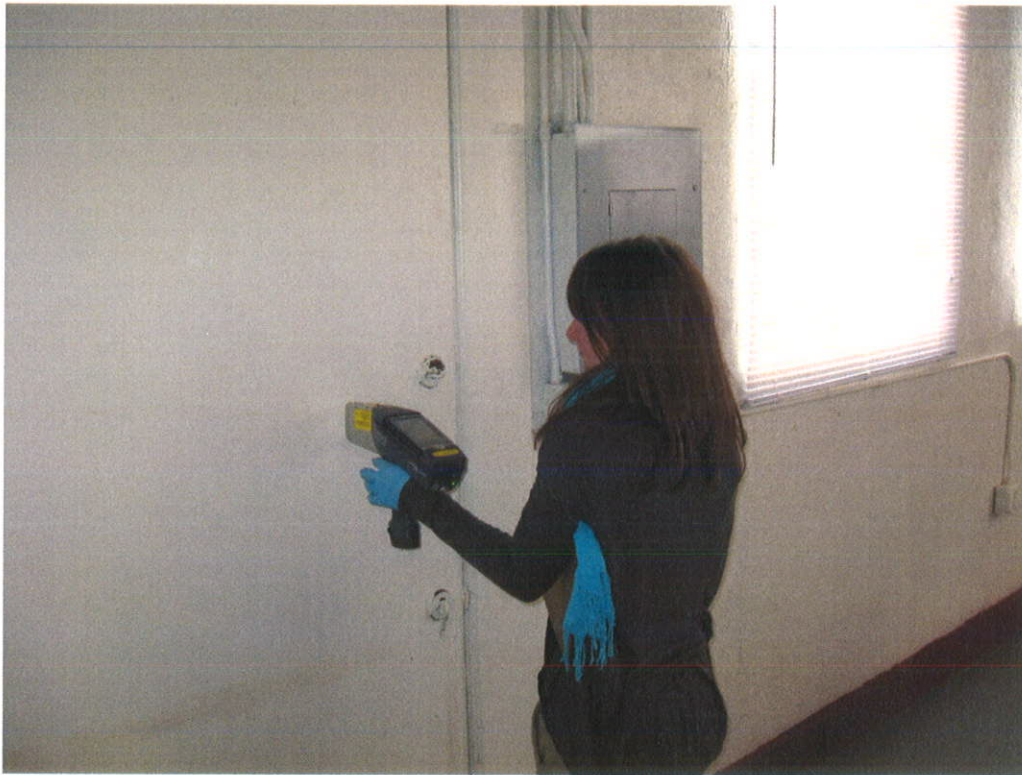
**PHOTO 1**

M. Dudevoir of START performing a lead-based paint test on the east-facing door with an Inovex XRF.

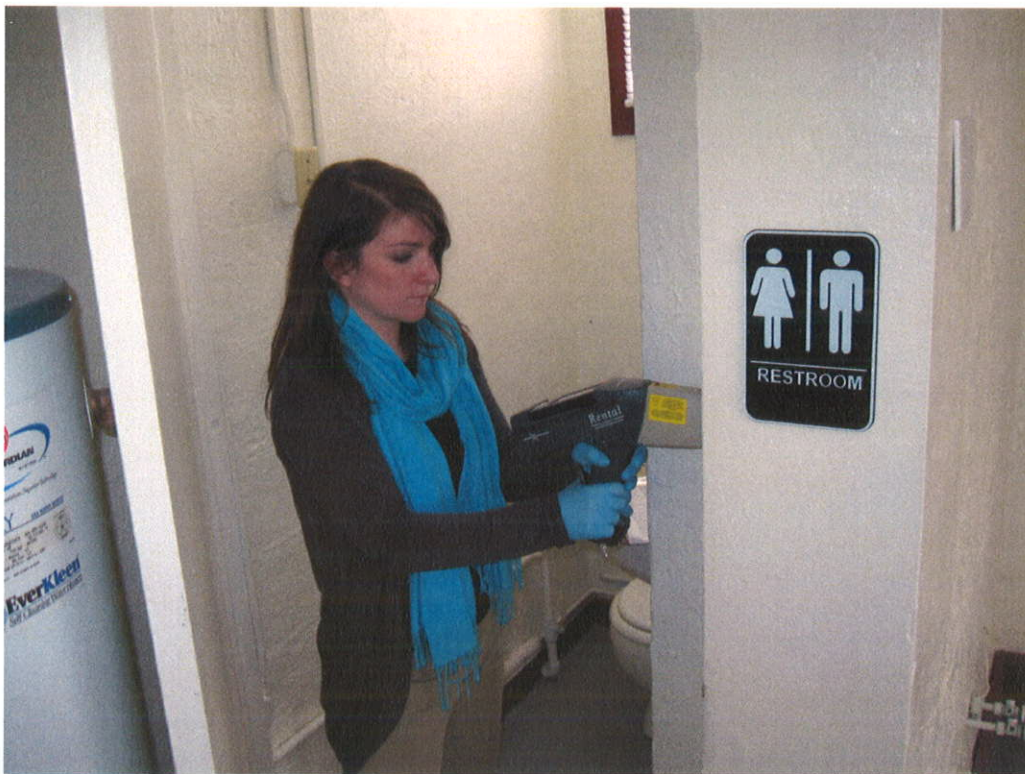
**PHOTO 2**

M. Dudevoir of START performing a lead-based paint test on the side wall looking north.

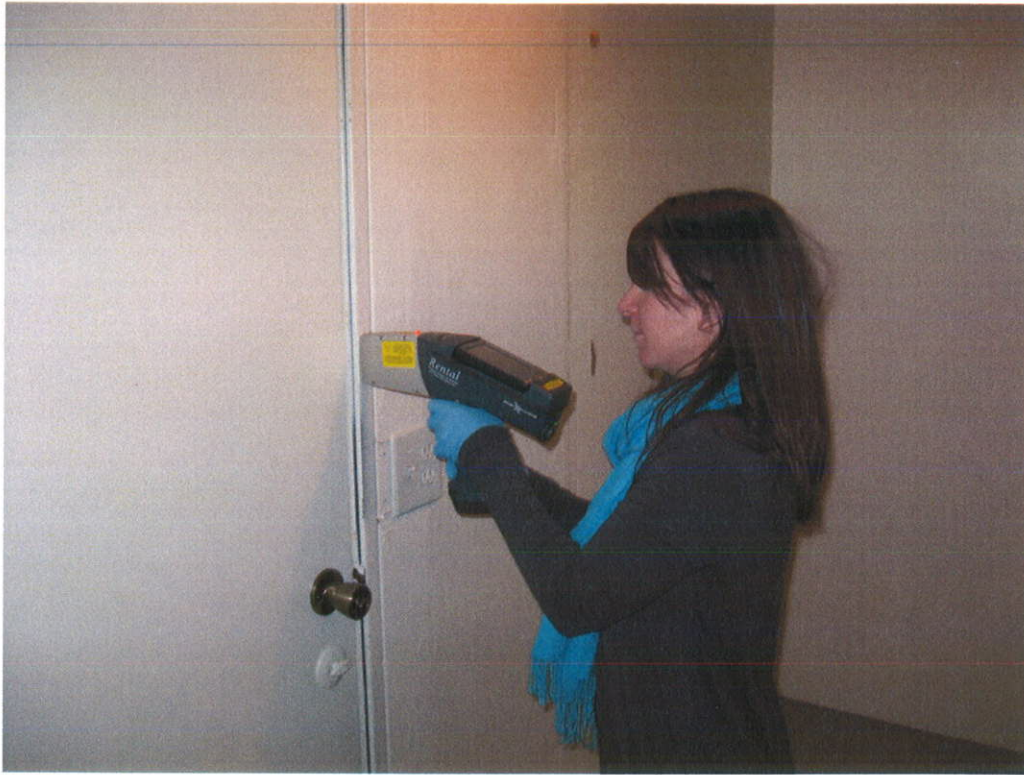
**PHOTO 3**

M. Dudevoir of START performing a lead-based paint test on the door panel of the storage room.

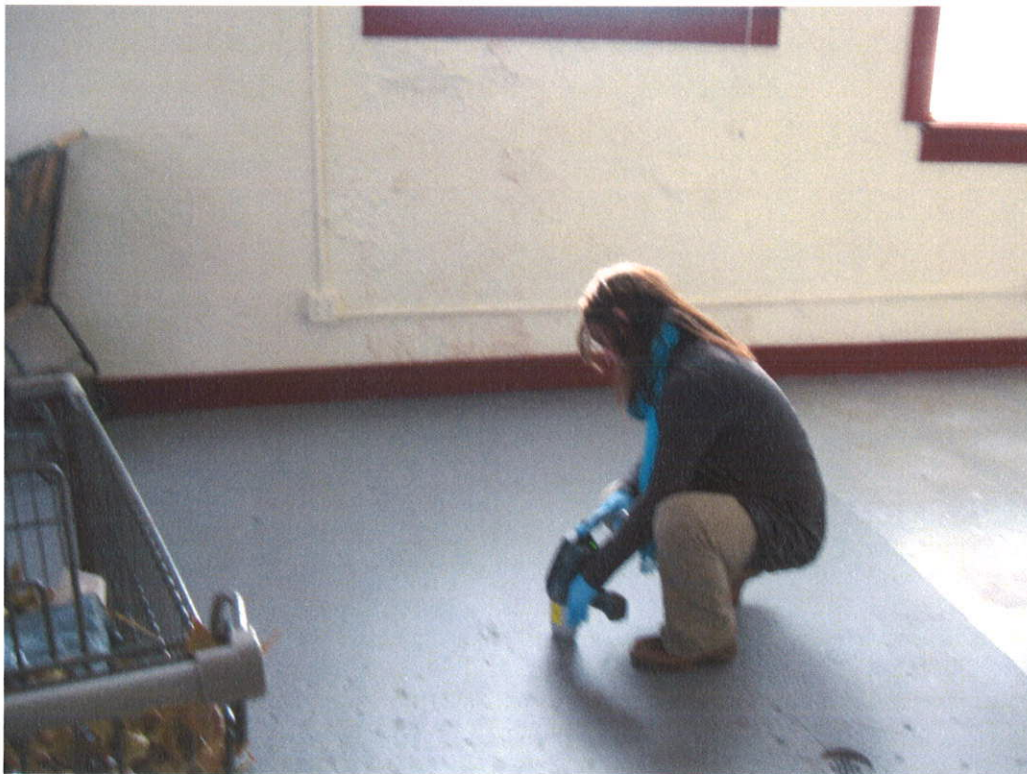
**PHOTO 4**

M. Dudevoir of START performing a lead-based paint test of the floor in the back room.

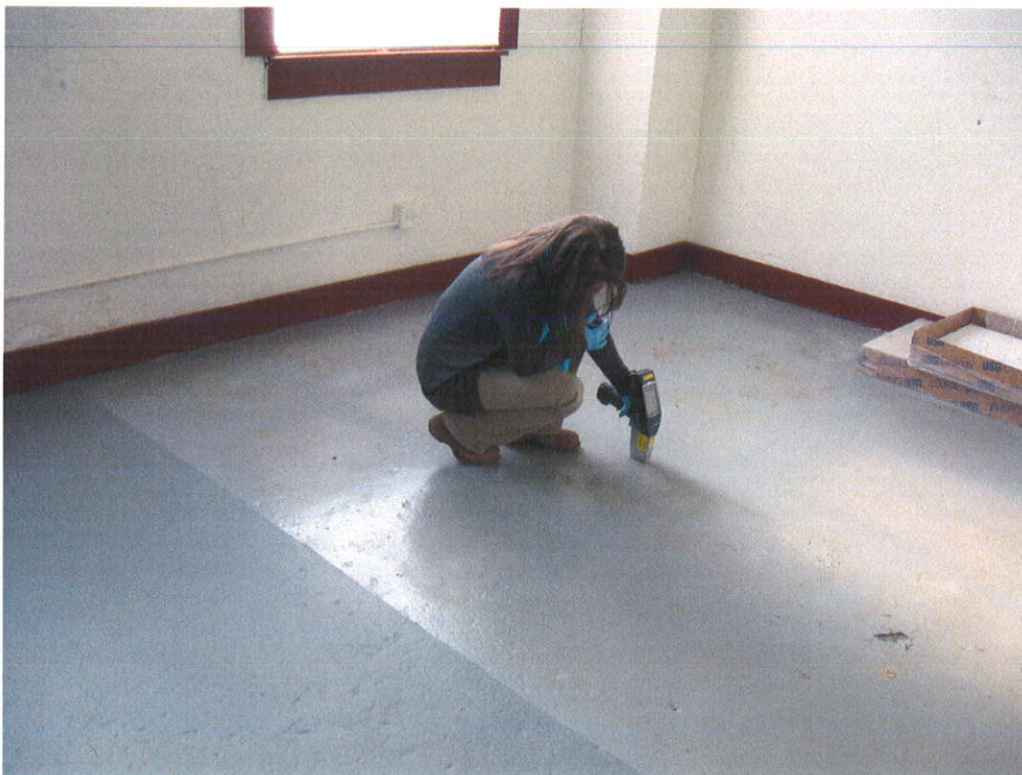
**PHOTO 5**

M. Dudevoir of START performing a lead-based paint test on the floor in the back room. (Note the two colors of paint.)

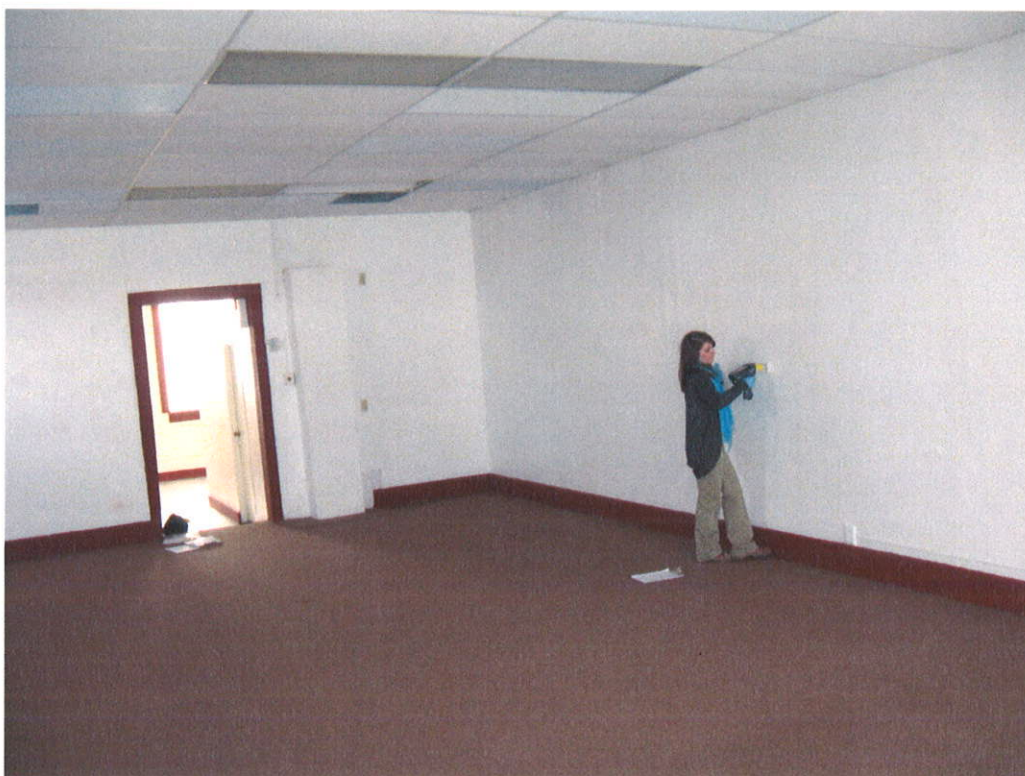
**PHOTO 6**

M. Dudevoir of START performing a lead-based paint test on the westernmost wall in the main room.

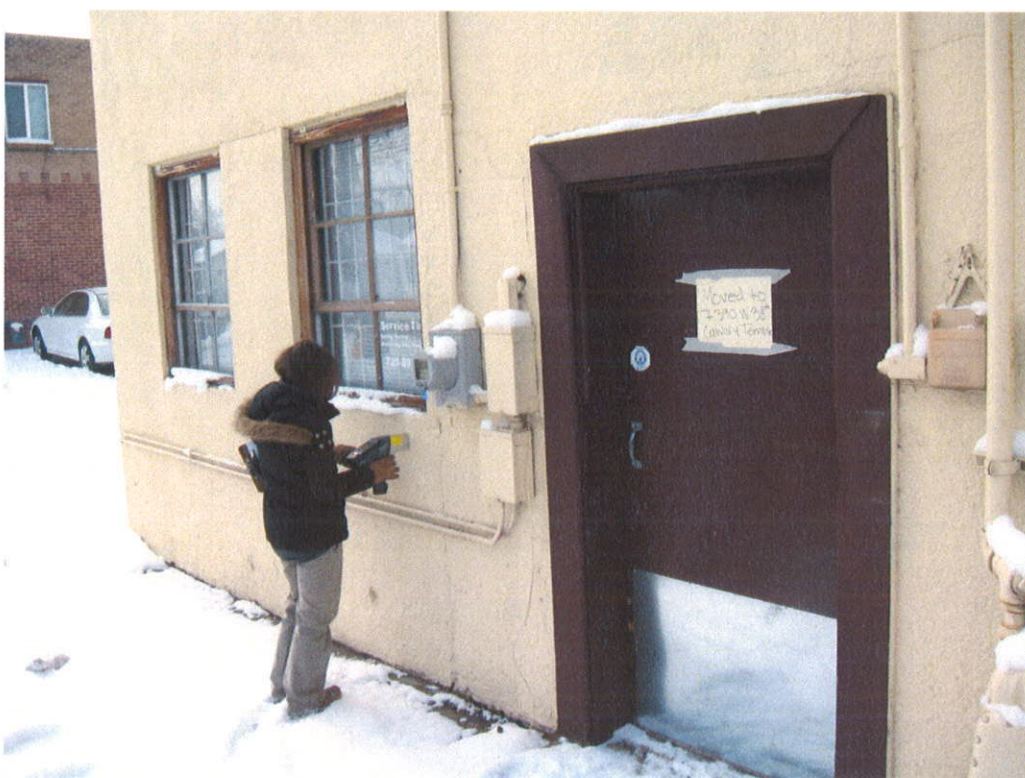
**PHOTO 8**

M. Dudevoir of START performing a lead-based paint test on the on the east wall outside of the building.

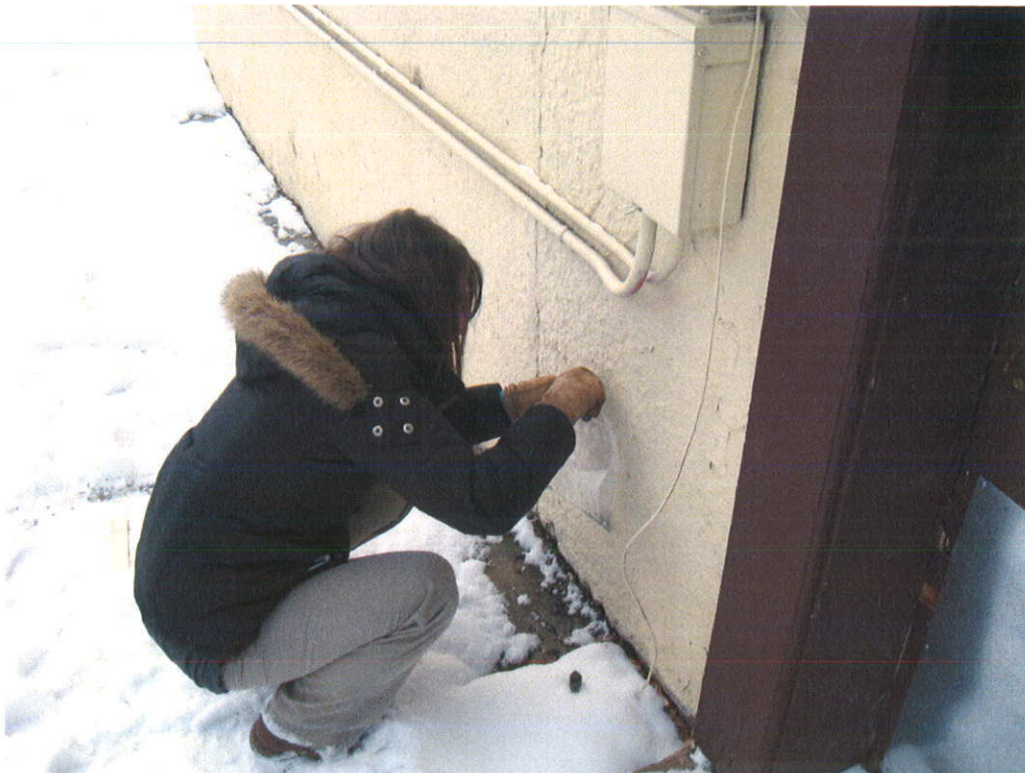
**PHOTO 9**

M. Dudevoir of START collecting a lead-based paint sample for laboratory analysis. Looking west.

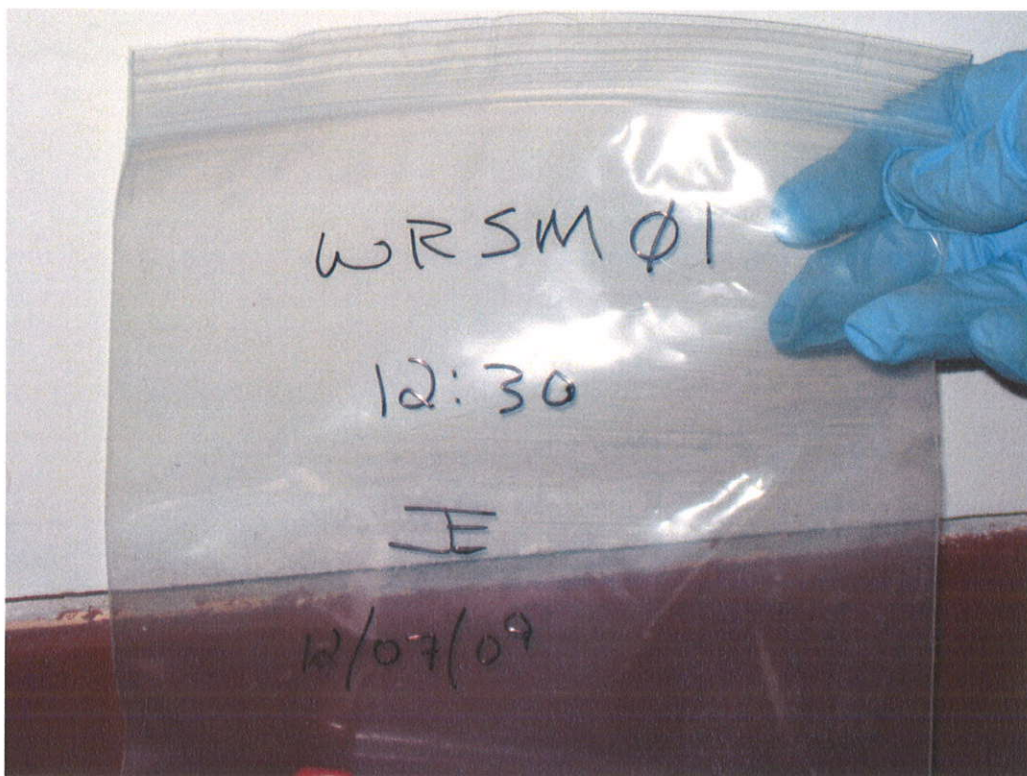
**PHOTO 10**

Collected suspected asbestos sample from location WRS M01. Looking south.

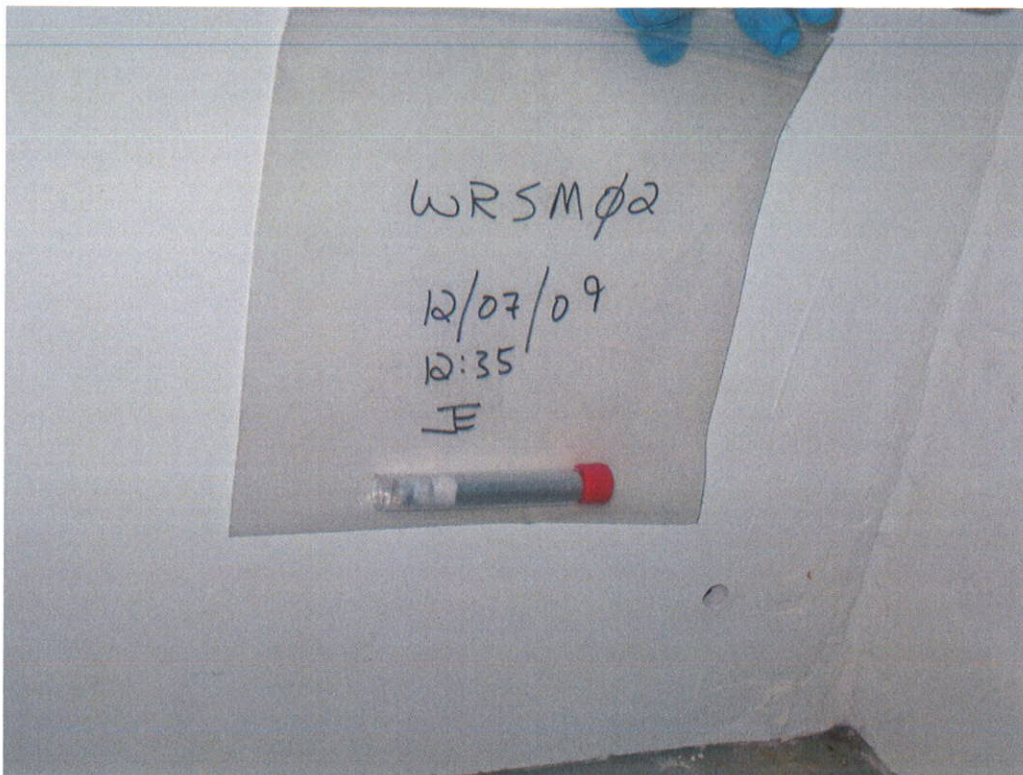
**PHOTO 11**

Collected suspected asbestos sample WRSM02. Looking south.

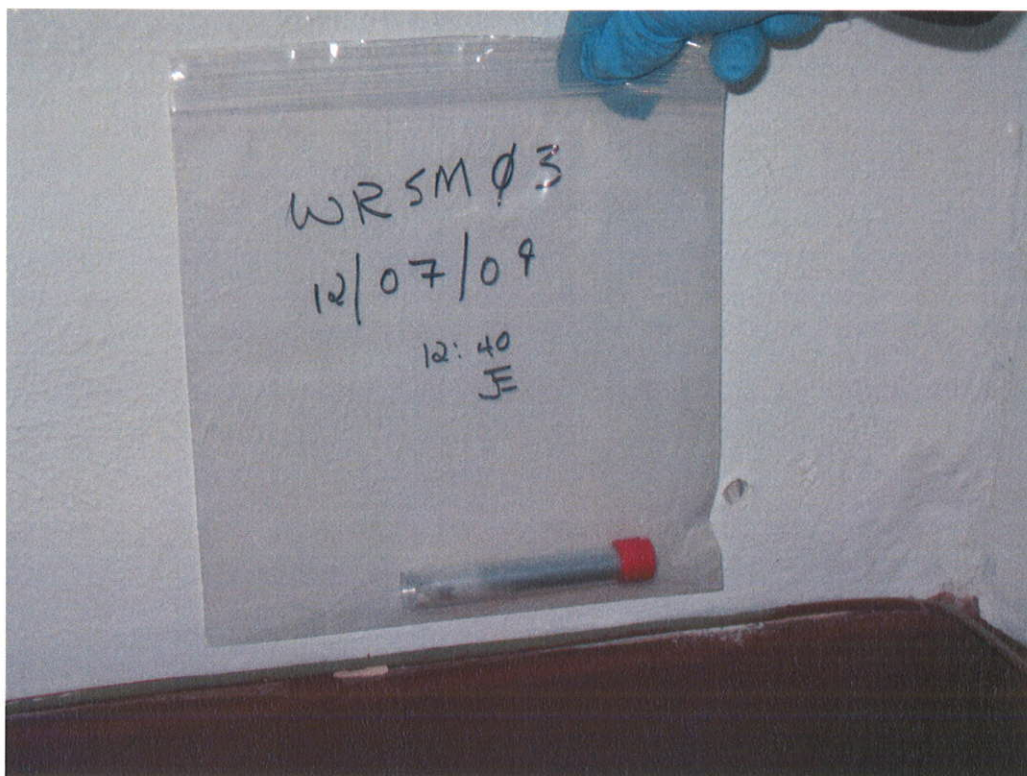
**PHOTO 12**

Collected suspected asbestos sample WRSM03 looking south.

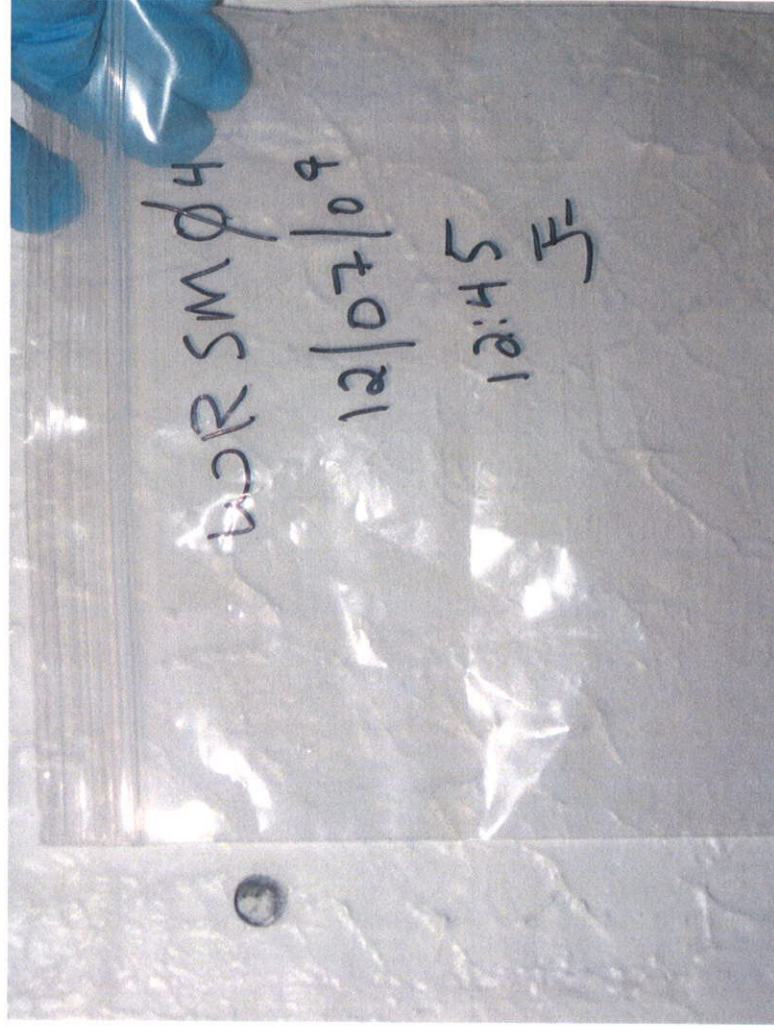
**PHOTO 13**

Collected suspected asbestos sample WRSM04. Looking north.

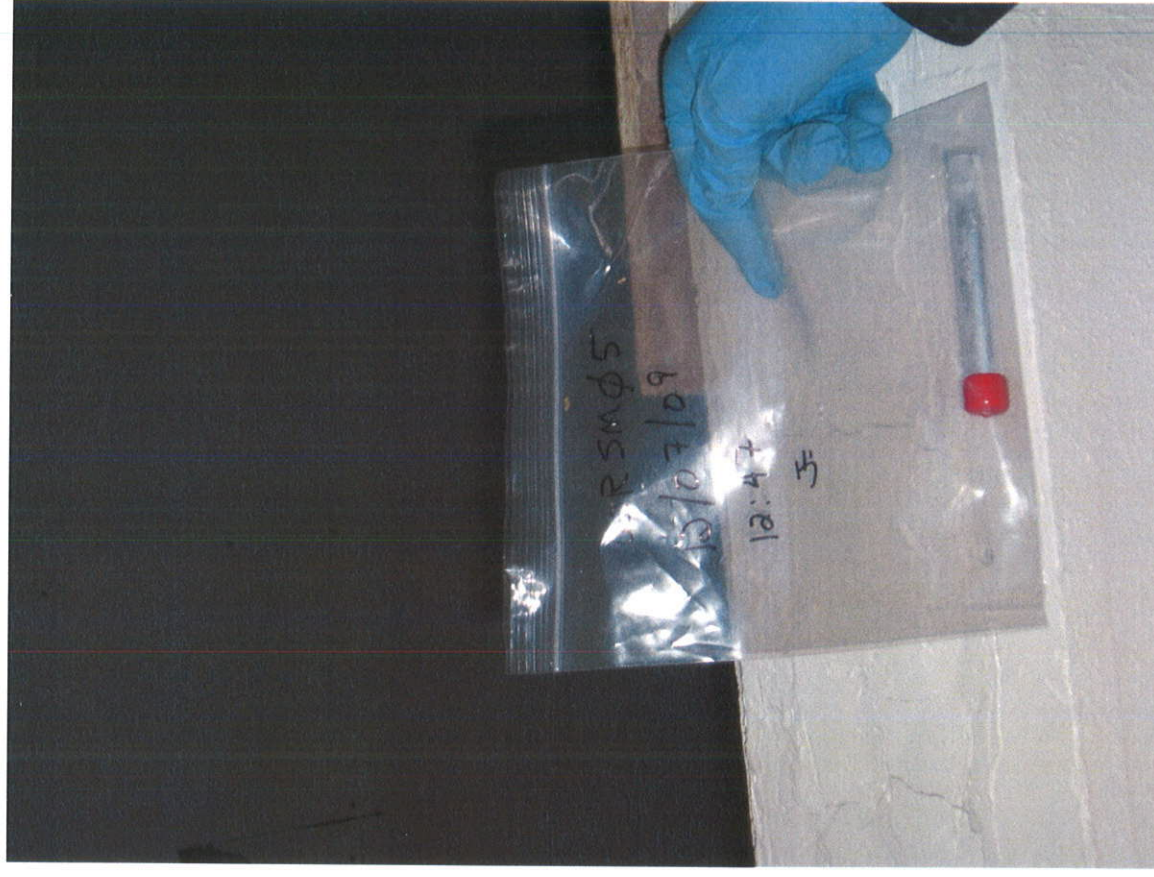
**PHOTO 14**

Collected suspected asbestos sample WRSM05. Looking north.

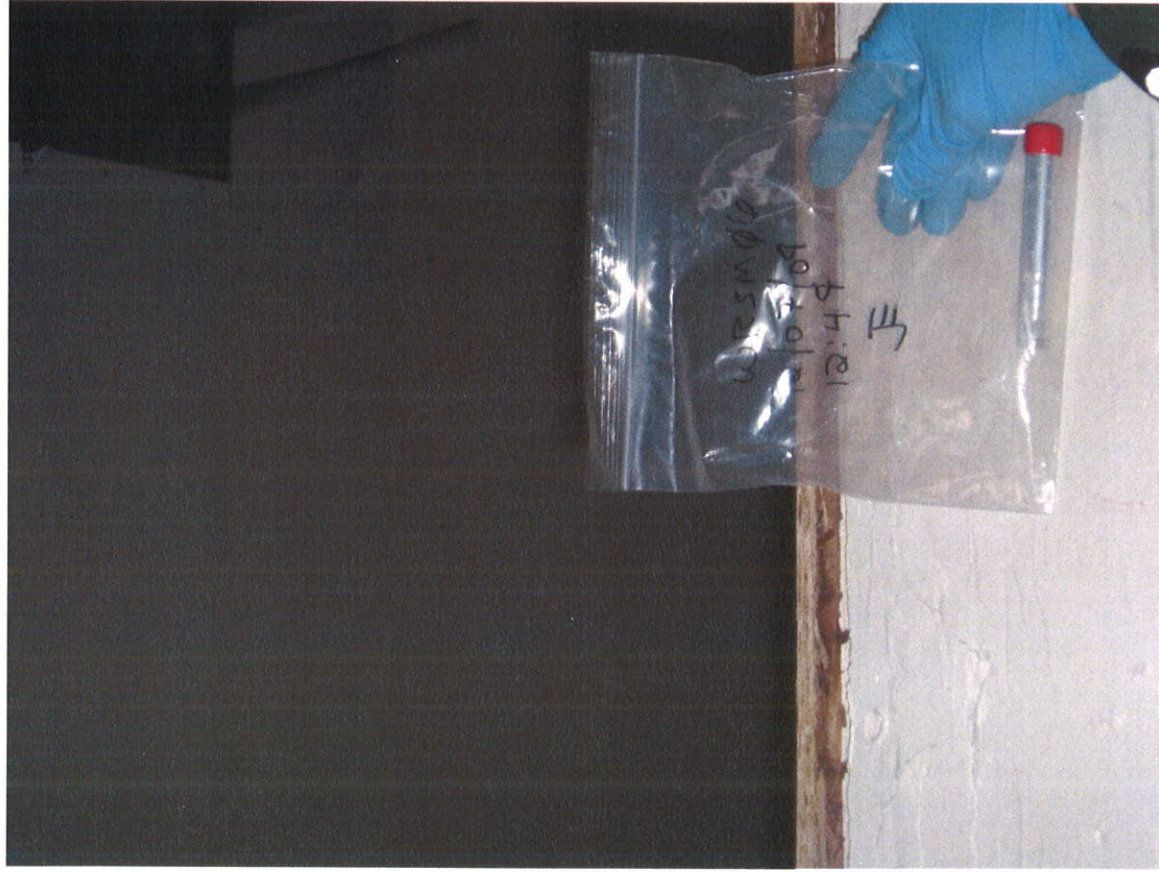
**PHOTO 15**

Collected suspected asbestos sample WRSM06 looking up.

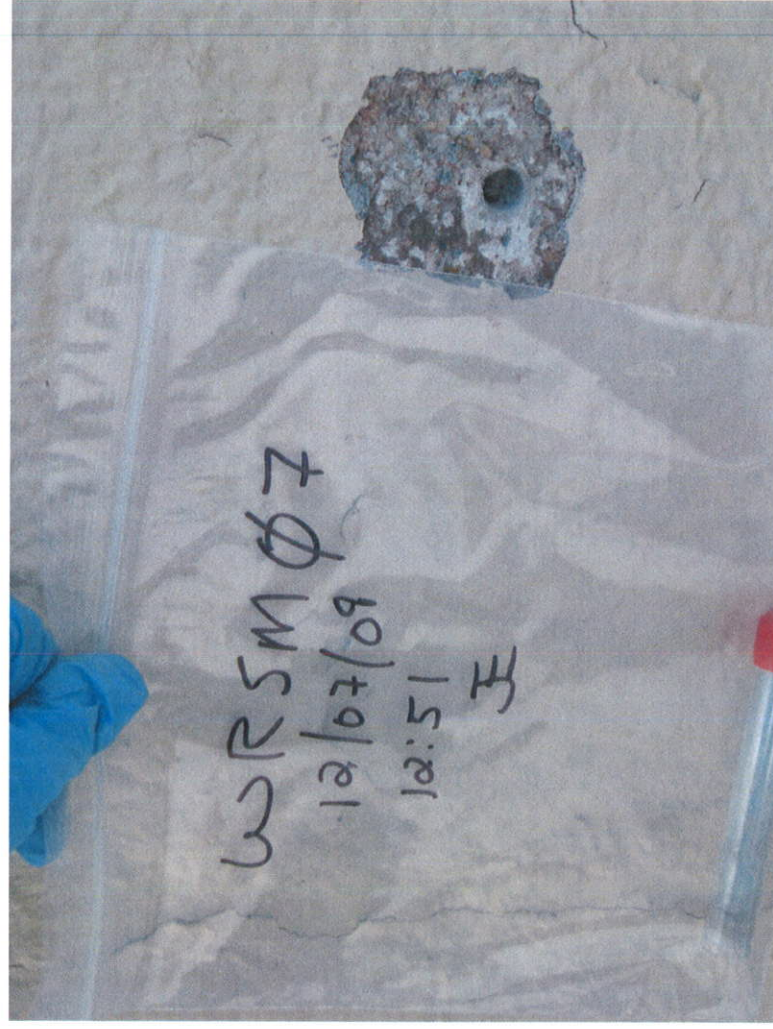
**PHOTO 16**

Collected suspected asbestos sample WRSM07. Looking up.

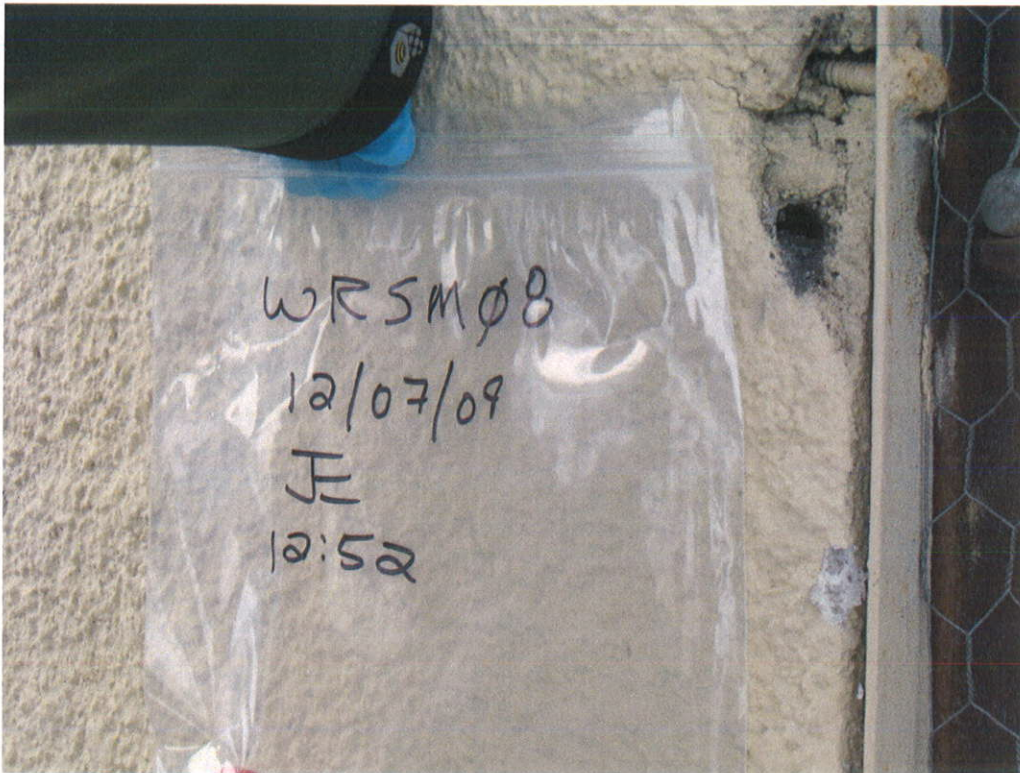
**PHOTO 17**

Collected suspected asbestos sample WRSMD8. Looking north.

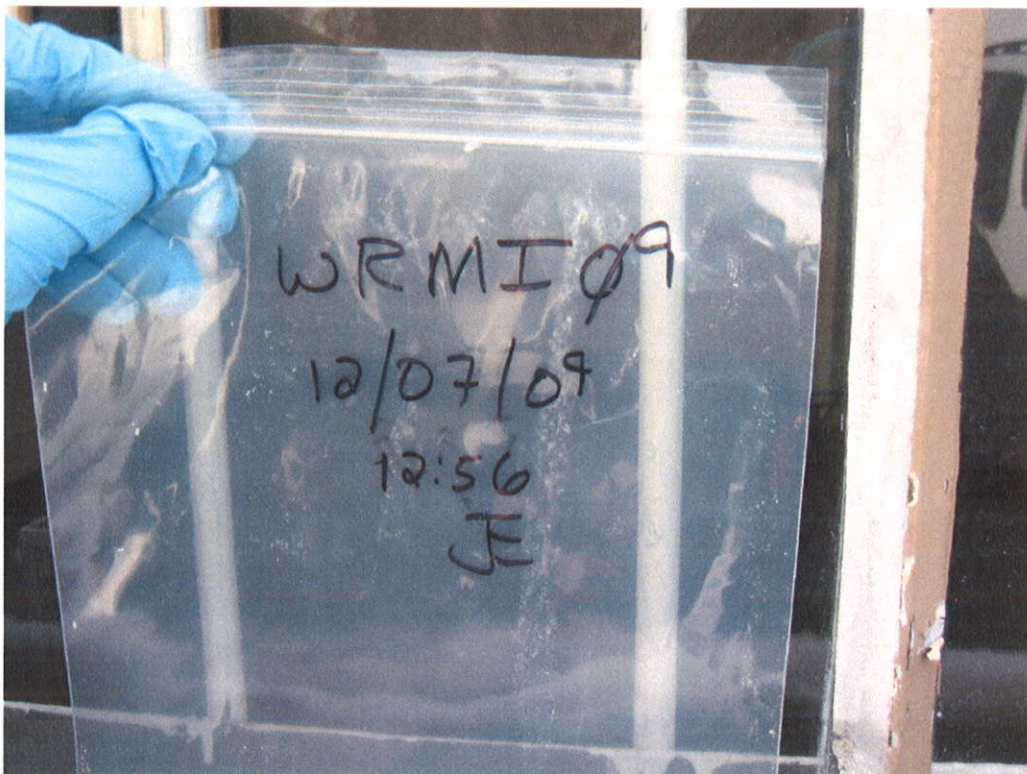
**PHOTO 18**

Collected suspected asbestos sample WRMI09. Looking west (window glaze)

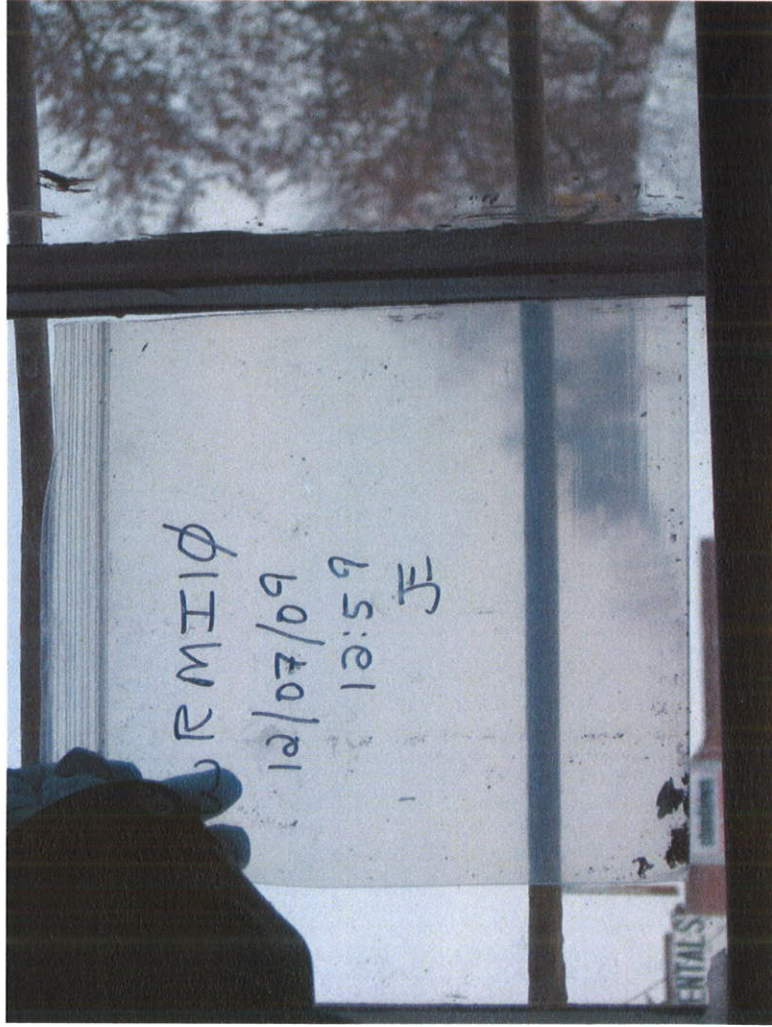
**PHOTO 19**

Collected suspected asbestos sample WRMI10. Looking east. (Window glaze.)

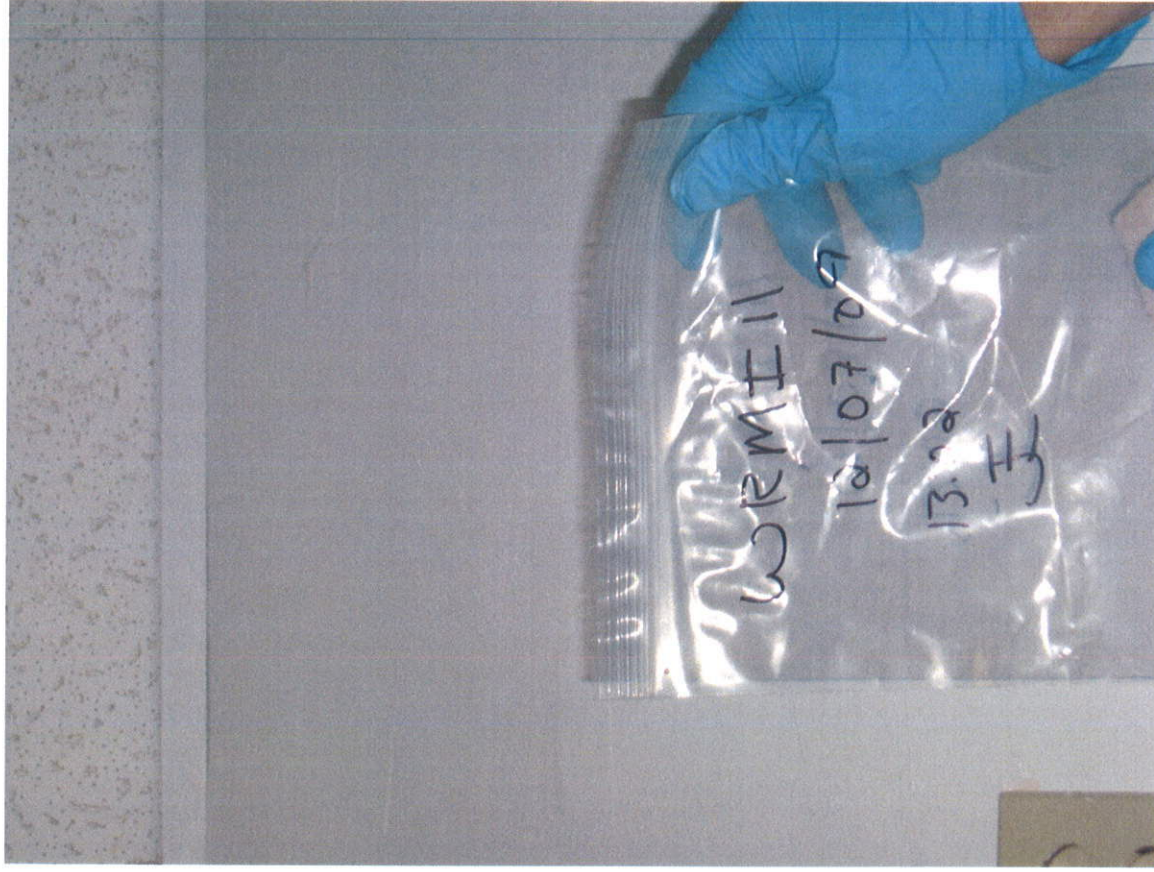
**PHOTO 20**

Collected suspected asbestos sample WRMI11. Looking up. (Ceiling tile.)

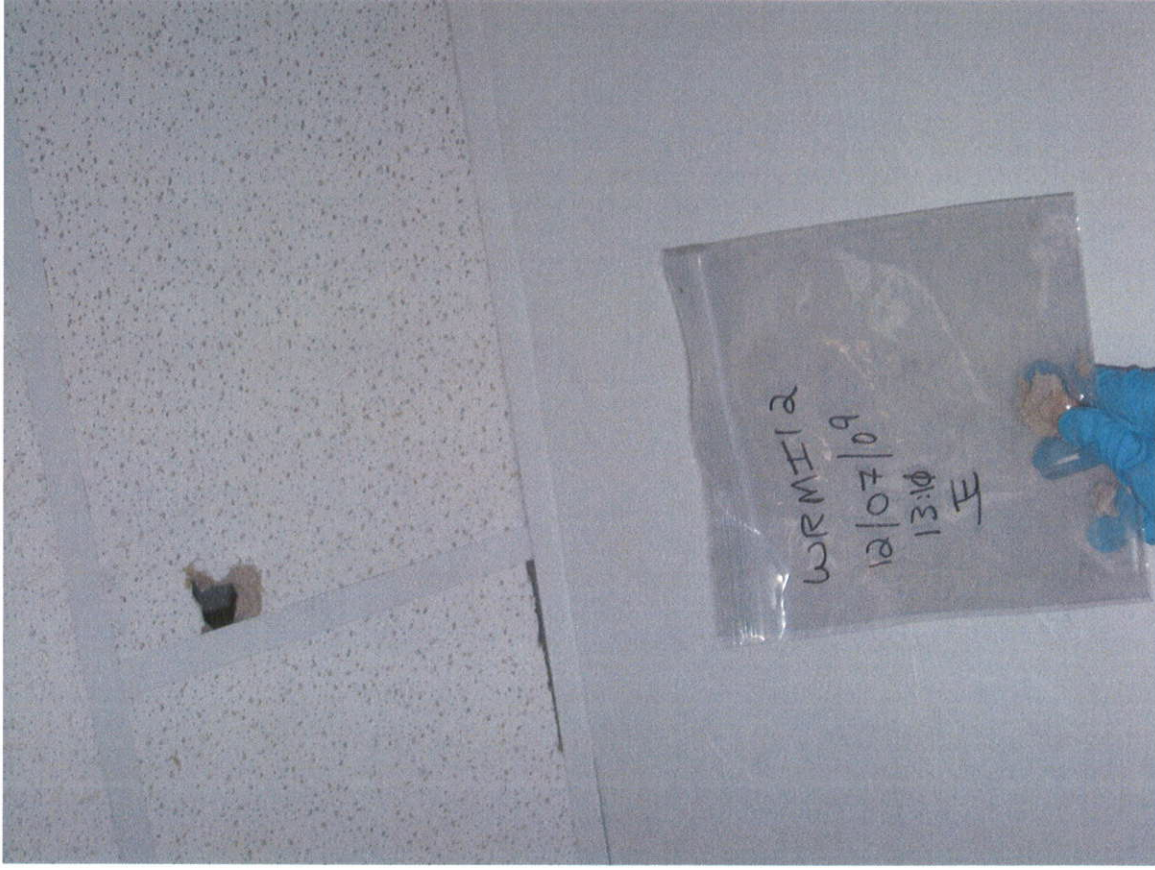
**PHOTO 21**

Collected suspected asbestos sample WRMI12. Looking up. (Ceiling tile.)

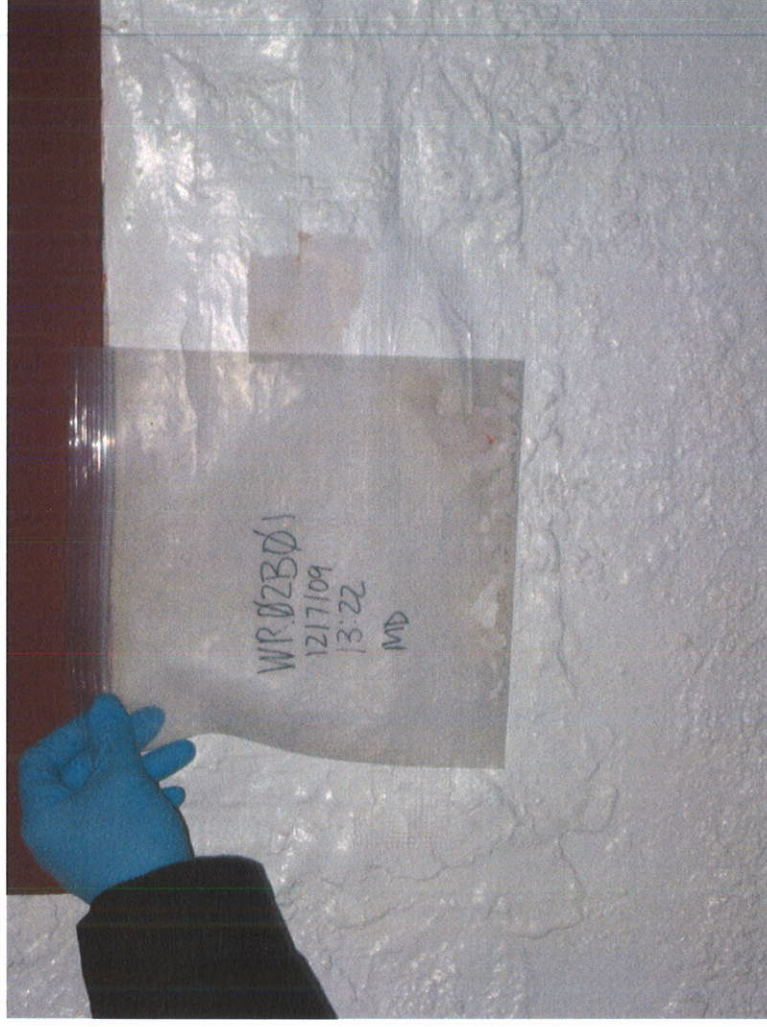
**PHOTO 22**

Collected suspected lead-based paint sample WR02B01. Looking south.

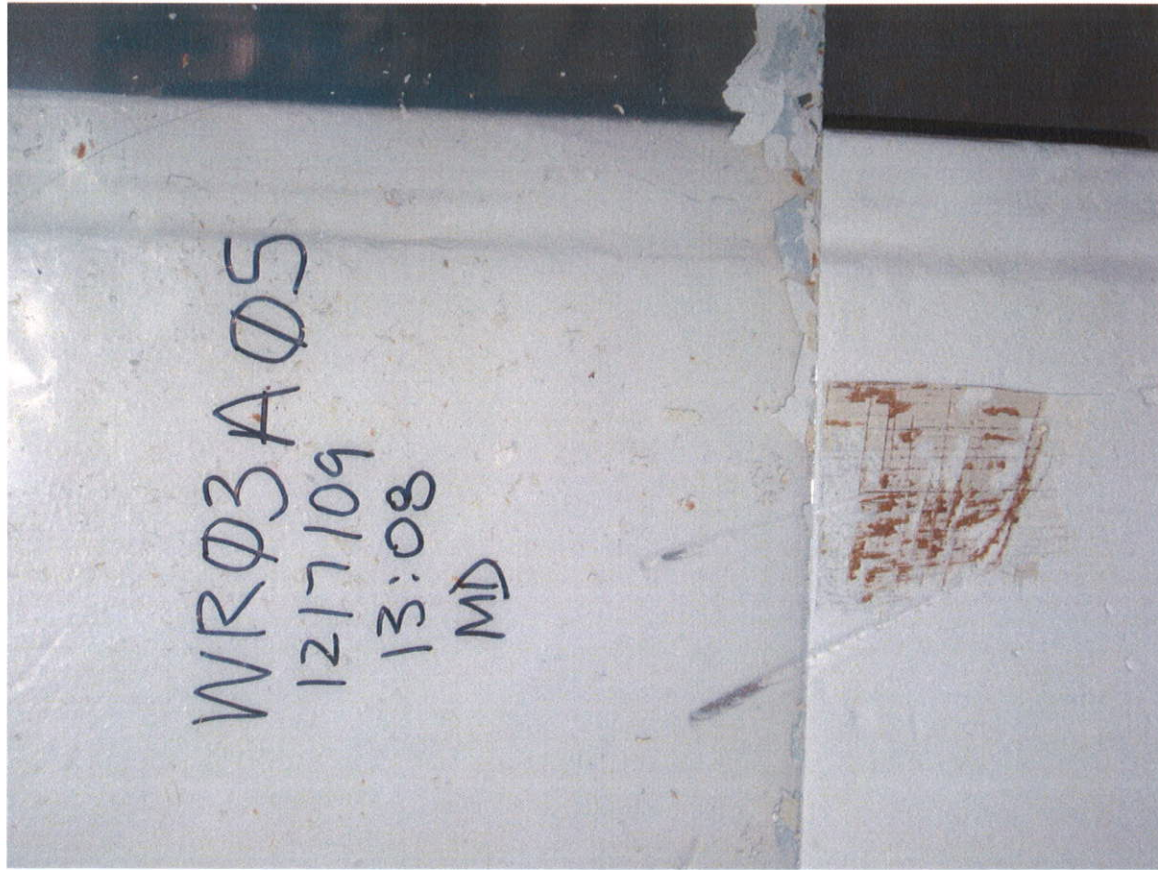
**PHOTO 23**

Collected suspected lead-based paint sample WR03A05. Looking west.

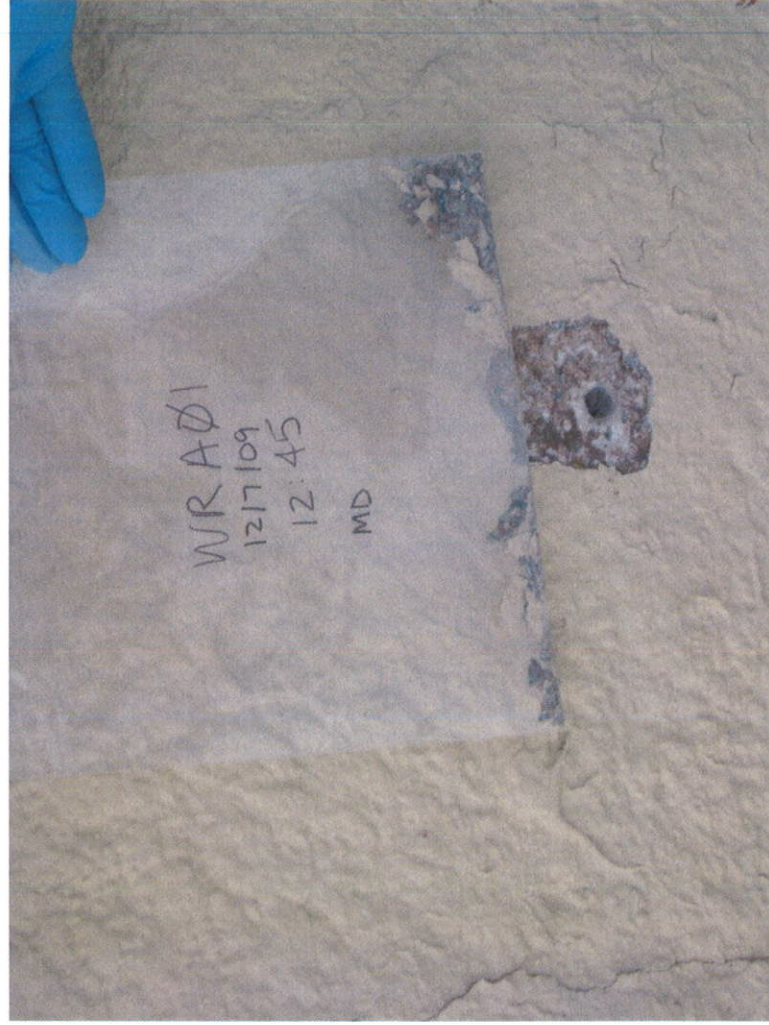
**PHOTO 24**

Lead-based paint was not identified on the interior of the 7100 West 38<sup>th</sup> Avenue building, but was found in two samples of the tan paint on the exterior of the 7100 West 38<sup>th</sup> Avenue building. XRF analysis performed on these samples indicated that the lead content was greater than one mg/cm<sup>2</sup>; therefore, the exterior of the 7100 West 38<sup>th</sup> Avenue building is considered lead-based paint. OSHA would consider exposure to workers involved in demolition or renovation of the exterior of the 7100 West 38<sup>th</sup> Avenue building to be a concern and would require worker exposure monitoring (CFR 1993). The Colorado Department of Health and Environment guidelines and regulations for lead-based paint will need to be followed and achieved if renovation of the exterior of the 7100 West 38<sup>th</sup> Avenue building takes place.

Collected suspected lead-based paint sample WRA01. Looking west.

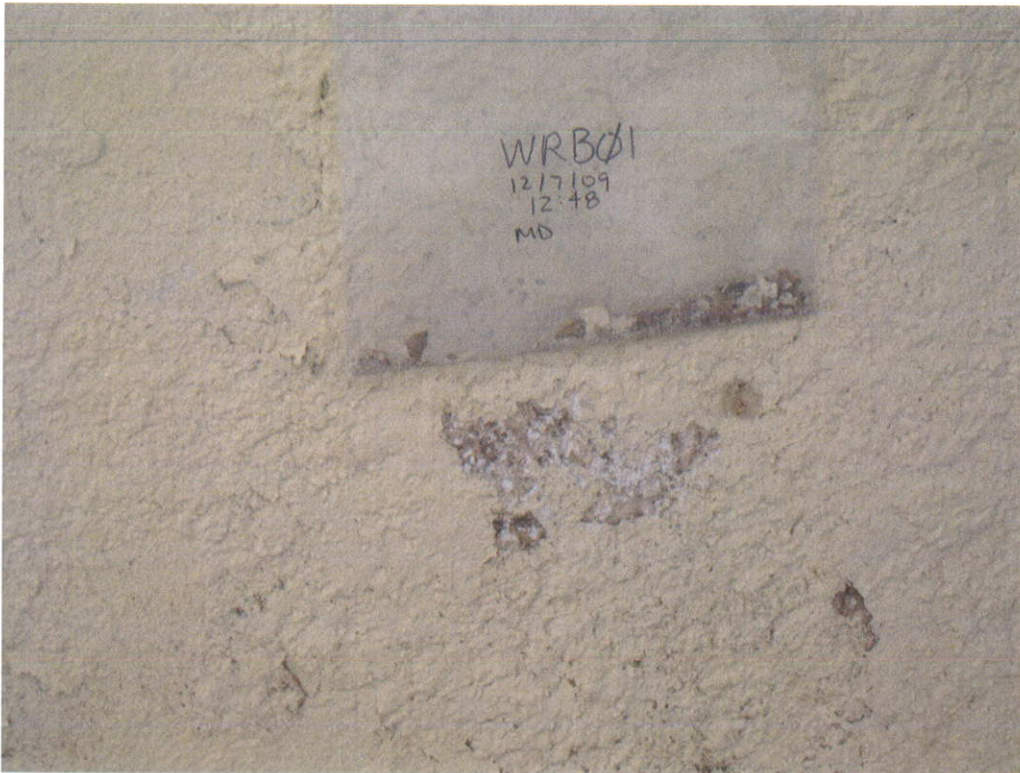
**PHOTO 25**

Collected suspected lead-based paint sample WRB01. Looking north.

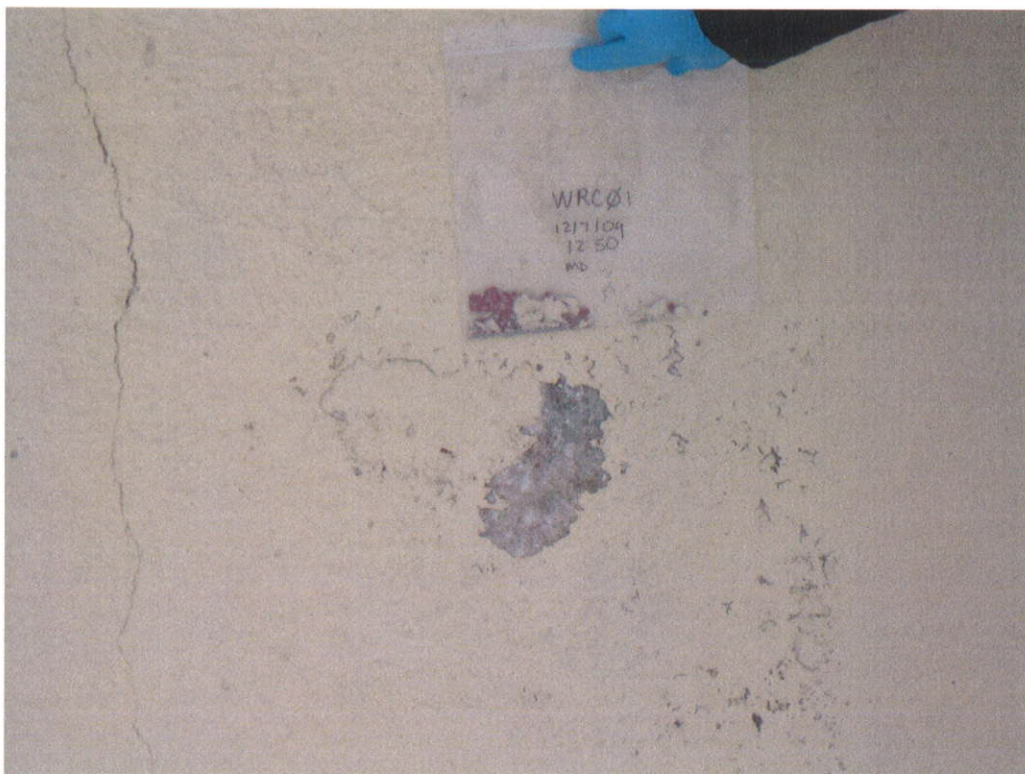
**PHOTO 26**

Collected suspected lead-based paint sample WRC01. Looking east.
